MISCELLANEOUS PAPER GL-79-20

**VISIT TO JAPAN TO OBSERVE DAMAGE
WHICH OCCURRED DURING THE NEAR
IZU OSHIMA EARTHQUAKES
JANUARY 14 AND 15, 1978**

William F. Marcuson III

August 1979

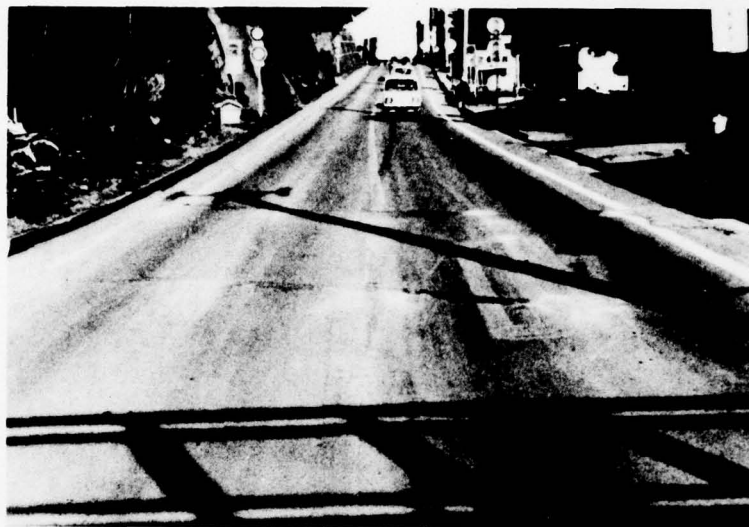
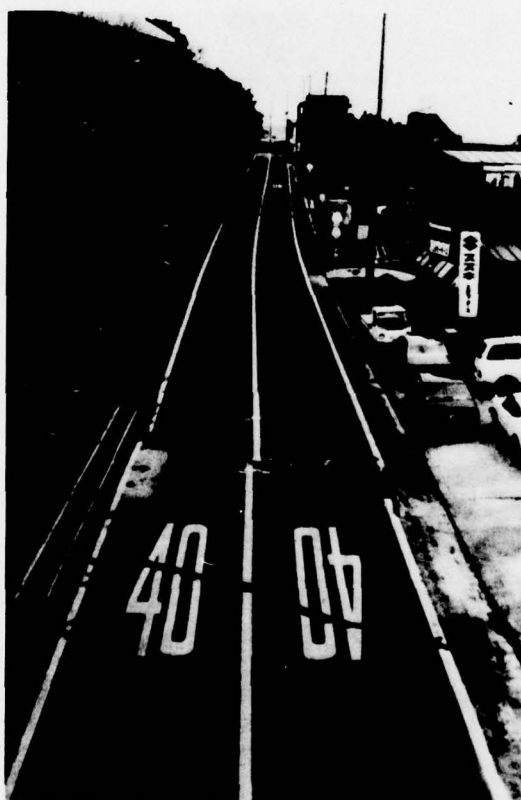
11. During the main shock the Inatori Fault, shown in Figure 5, was subjected to right lateral movement. The maximum offset on the Inatori Fault was about 18 cm; Figure 13 shows photographs of this 18-cm offset along the Inatori Fault as it crosses a highway in the town of Inatori. Various Japanese engineers and scientists reported horizontal movement of as much as 60 cm; however, no displacements larger than 18 cm were actually observed.

Figure 13. Photos showing Inatori fault offset

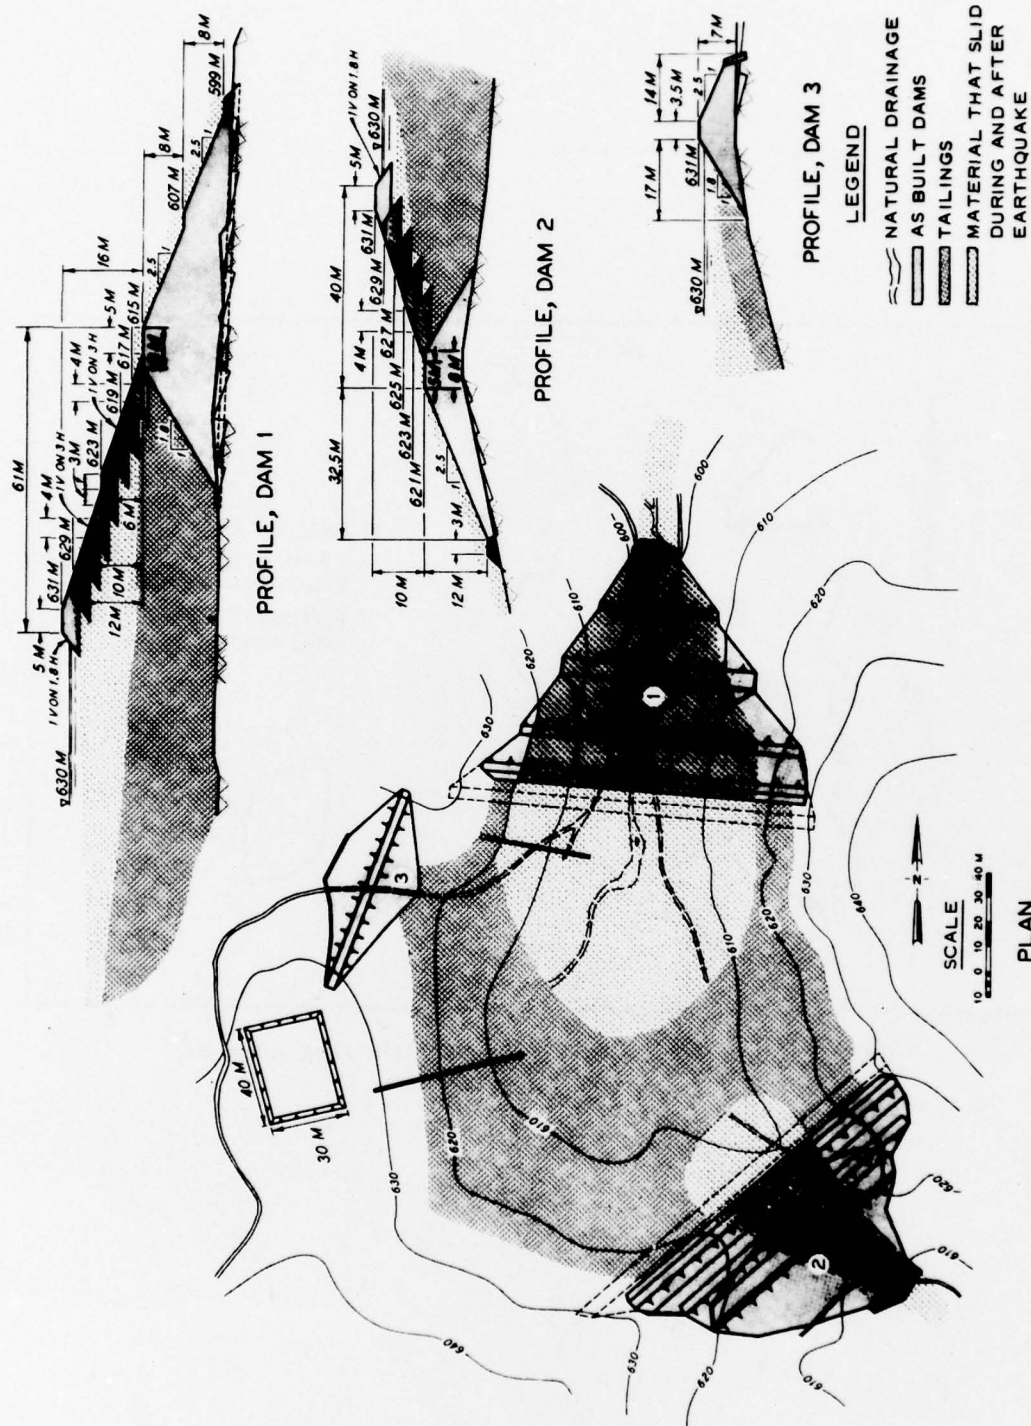
14. Since 1965 the tailings were deposited in a bowl-shaped structure on the top of a mountain. This bowl-shaped structure is formed by three dams. Figure 17 shows a plan view of this bowl-shaped structure. Also shown in this drawing are cross sections of the three as-built dams. For convenience these dams will be called: Dam No. 1, located in the most northerly direction and shown at the top of Figure 17; Dam No. 2, which is the southeasterly dam and is shown below Dam No. 1 on the right side of Figure 17; and finally Dam No. 3, which is the westerly dam. A cross section of Dam No. 3 is shown at the bottom of Figure 17.

Figure 17. Plan view and cross sections of the tailings dams

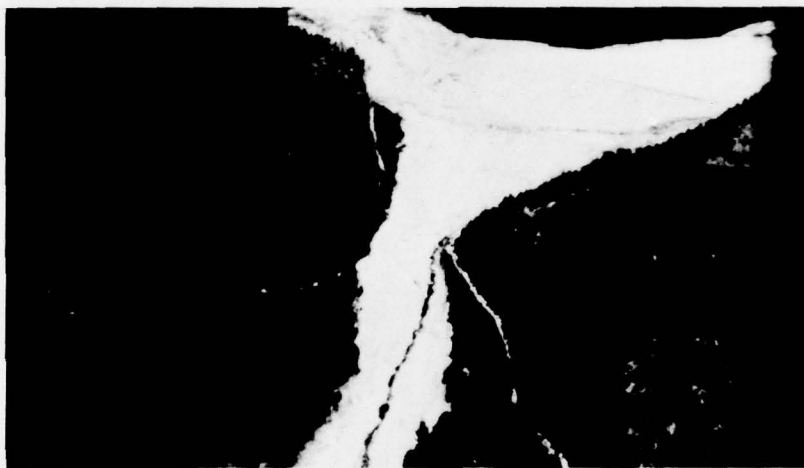
18. Main shock. The main shock occurred on January 14 at 12:24 p.m. As a result the tailings behind the No. 1 Dam liquefied. With this liquefaction and resulting loss of shear strength the small dikes became unstable and thus about 80,000 cu m of contaminated tailings flowed out of the reservoir. These tailings flowed down the mountain-side and into a stream and then some 30 km down the stream into the ocean. Figure 17 shows a plan view of the tailings reservoir with dams. The crosshatched zones show where liquefaction and flow took place. Figure 17 also shows cross sections of the dams after the failure had occurred. Figure 18 shows aerial photographs taken of the tailings reservoir and showing the No. 1 Dam after it had failed. The residue left by the tailings flowing down the mountainside can be seen in the photographs. Figure 19 shows the streambed after the earthquake. Note the gray markings on the side of the streambed indicating how high the tailings must have been when they flowed down the river. This is about 1-1/2 m up on this streambed wall. In Figure 20 one can see heavy equipment removing the tailings deposit from the streambed. At this point the tailings deposit is about 2 m thick. Figure 21 shows sand boils that occurred in the tailings during the main shock.

Figure 18. Aerial views of the Mochikoshi Mining Co.'s
tailings dam No. 1 after failure

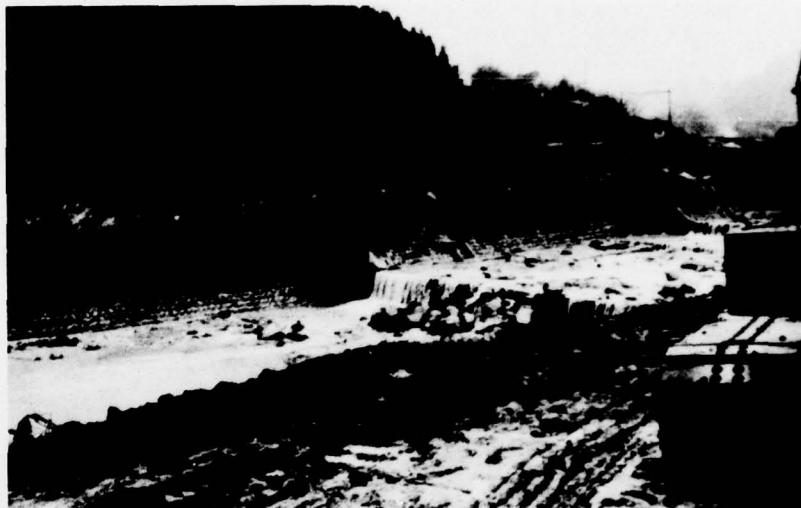
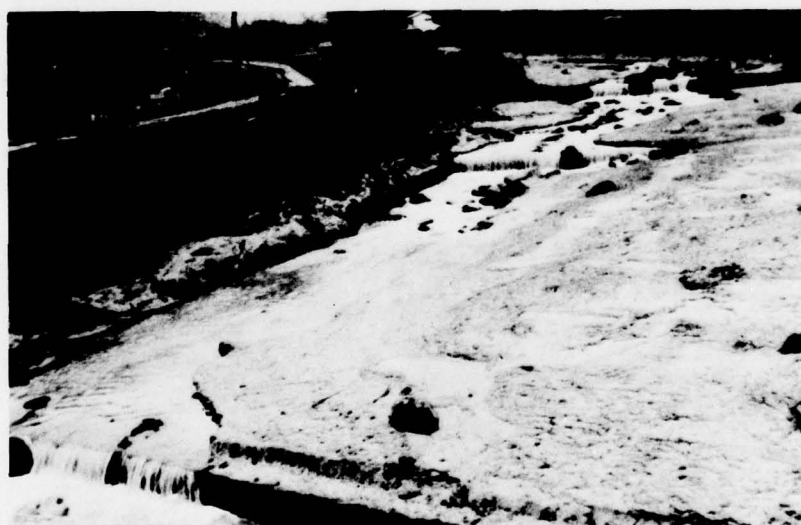
Figure 19. The streambed about 1 km downstream of the tailings dam - after the failure

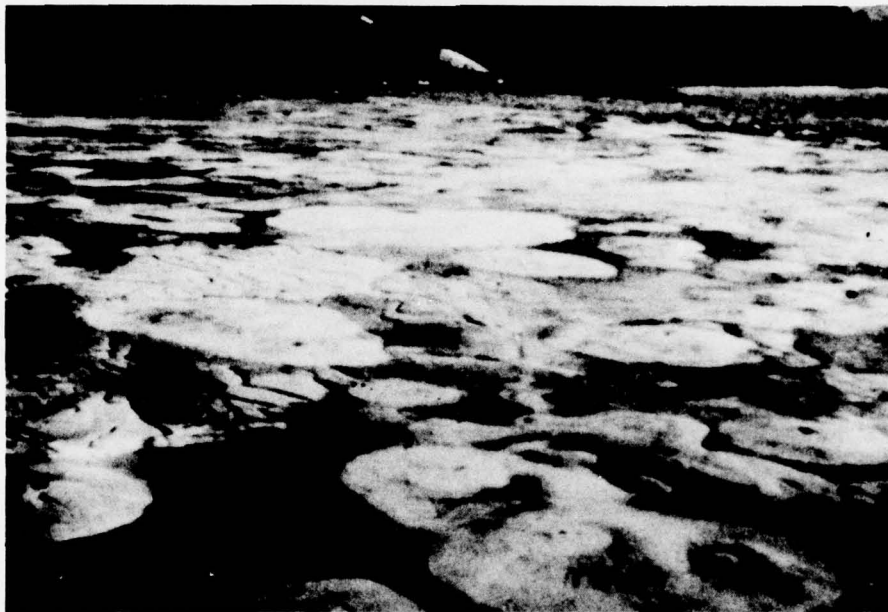
Figure 21. Sand boils in tailing deposit after the earthquake

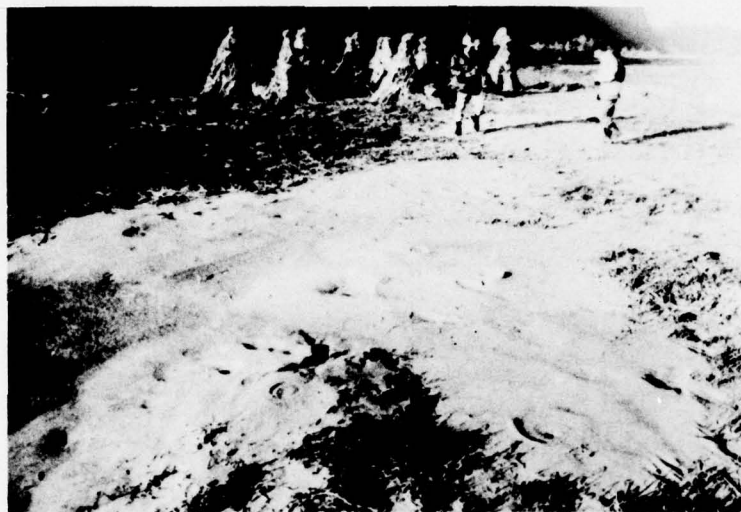
21. About 15 min after the main shock, sand boils occurred in the old tailings deposit areas (those used prior to 1965). This area had had about 1/3 m of fill deposited on the surface of the tailings and grass had been planted and the area is now used for grazing cattle. Figure 22 shows pictures of the tailings material after it had boiled up as a result of the earthquake.

Figure 22. Soil boils in old tailings deposits

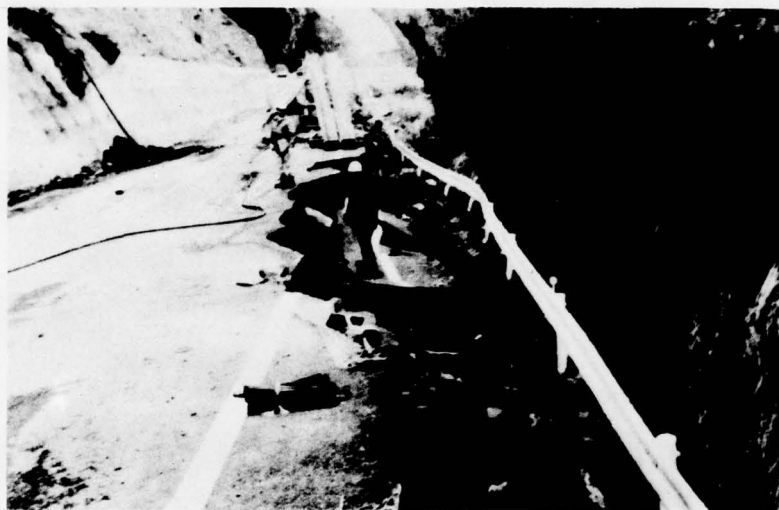
28. If one travels the highway leading from the damsite in a southerly direction to the coast (see Figure 26) many landslides and rockfalls can be seen. As stated previously, the Izu Peninsula is primarily volcanic in origin. The area is very rugged and mountainous. As a result most of the damage resulted from landslides and rockfalls. Where cut and fill operations had been used to construct highways along the mountainside the fill portions occasionally slumped. This is seen in Figure 27. Figures 28 and 29 are photographs showing landslides and rockfalls that occurred along this highway.

Figure 27. Examples of failures where the highways had been constructed using cut and fill techniques

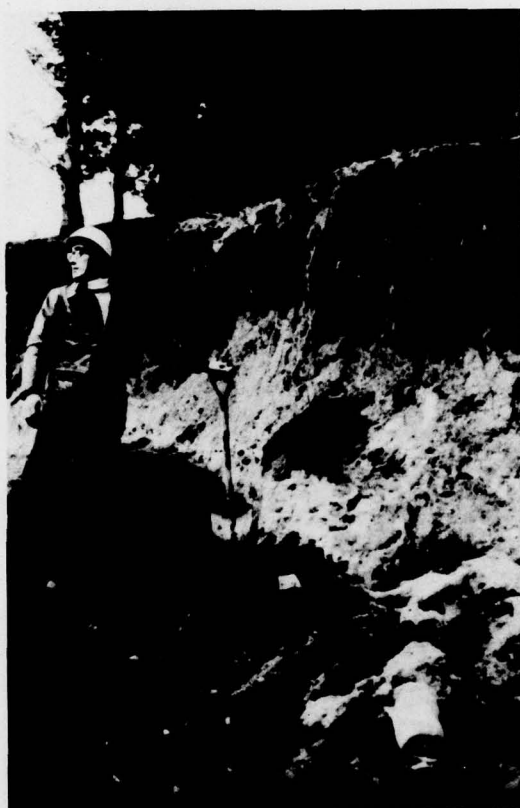
turned and flowed down the valley. Figure 34 is a photograph taken of the scarp remaining after the slide. The surficial deposits were composed of loam and weathered volcanics. Immediately below this is a layer of scoria. Immediately below the scoria is a volcanic tuff which is hard to chip with a shovel. Below this layer of volcanic tuff is a soft layer of plastic clay (visually classified CH). This can be seen in the photographs in Figure 35. There are two schools of thought concerning the failure plane of this slide. One school says that the failure plane is in the scoria. The other school of thought, which appears to be more logical, is that the failure plane is located in the soft clay below the volcanic tuff. This appears more logical because of the large chunks of tuff which slid during the earthquake (see Figure 36). This soft clay, was found at the head of the slide and also at the existing surface toward the center of the slide area. Figure 37 is a photograph taken of this material in the center of the slide area. It is believed that this layer of soil was continuous over the entire slide surface.

Figure 34. View of scarp
of landslide

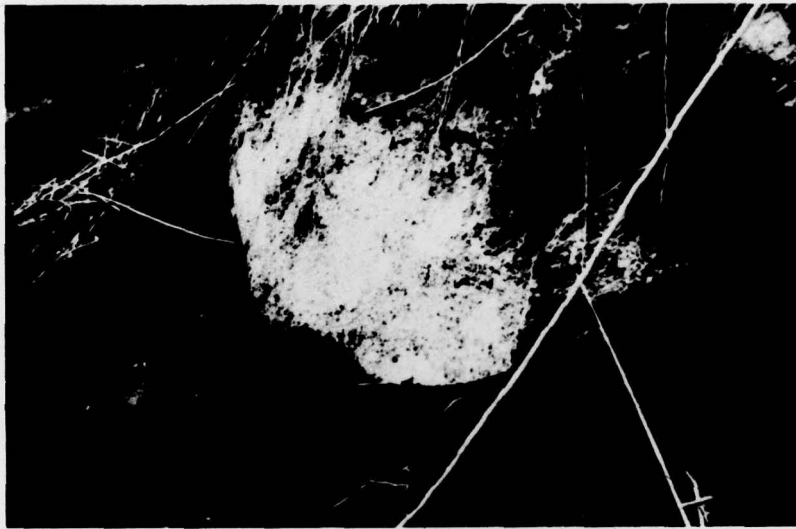
Figure 35. View of postulated zone of weakness

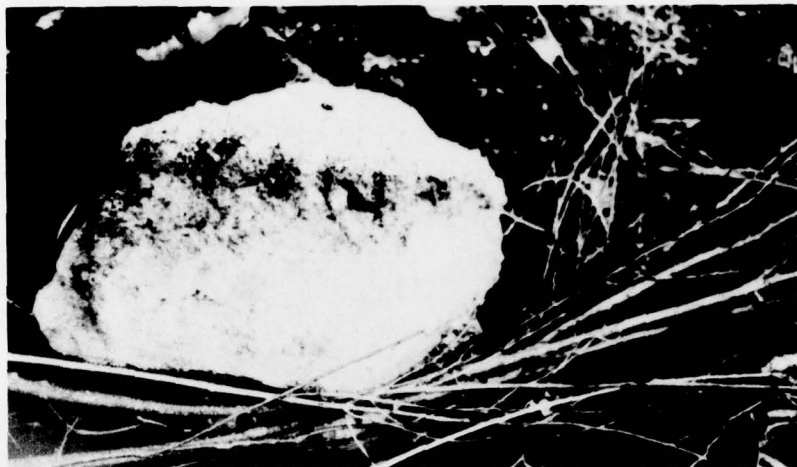
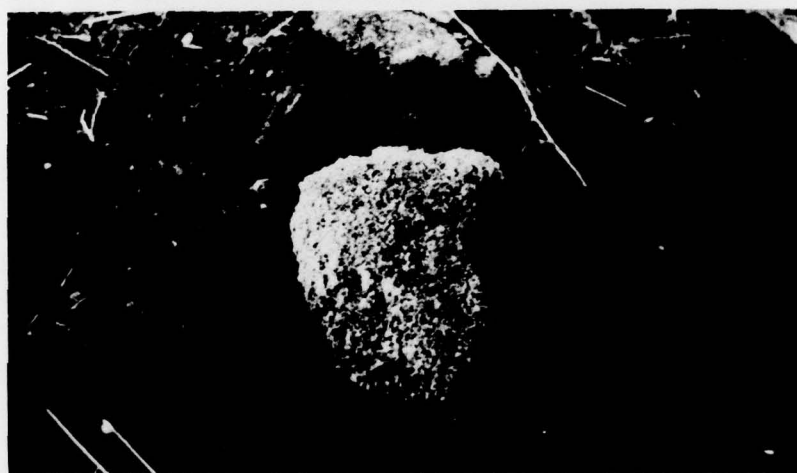
Figure 36. Photos of material of the slide
